Ames Intermodal Project Cast in Place Concrete Stair Repair Proposal

July 27, 2012

NON-DESTRUCTIVE TESTING SERVICES REPORT

Report Number: AB123501.0001
Service Date: 06/20/12
Report Date: 06/28/12

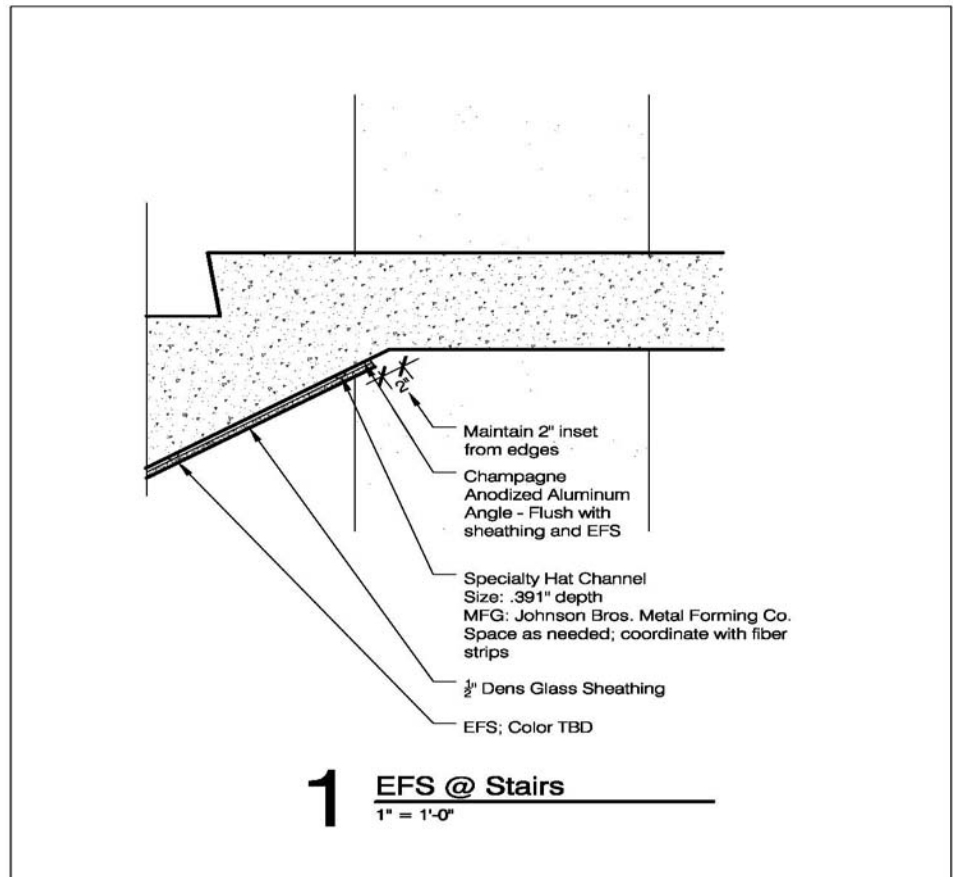
ISU, Cy Ride, and Neumann Monson have indicated that aesthetic concerns are critical as well as the structural integrity of any proposed repair. The stairs on this project are key design feature of the building. Therefore, after several meetings and reviewing mock ups of the proposed repairs and possible coating material Weitz is proposing that the repair work be covered by a mechanically attached furring, Dense Glass, and an EIFS system which would produce a “sand” type finish matching the exterior bulkhead adjacent to the Terminal Building. The total thickness of the solution would be approximately 1 inch. A pre finished sheet metal trim piece would be utilized to provide a finished edge of the system.
