## **STAFF REPORT**

### **4006 STONE BROOKE PROPERTY OWNER CONCERNS**

**AUGUST 12, 2014**

**Stone Brooke Subdivision  
Drainage Channel Review**

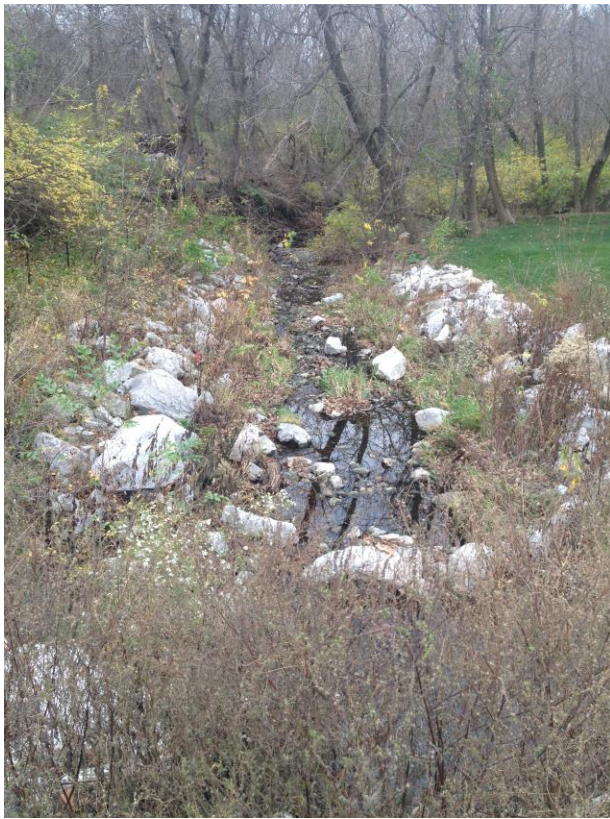
*Outlet of culvert downstream of Hoover Avenue/Edgewater Drive.*

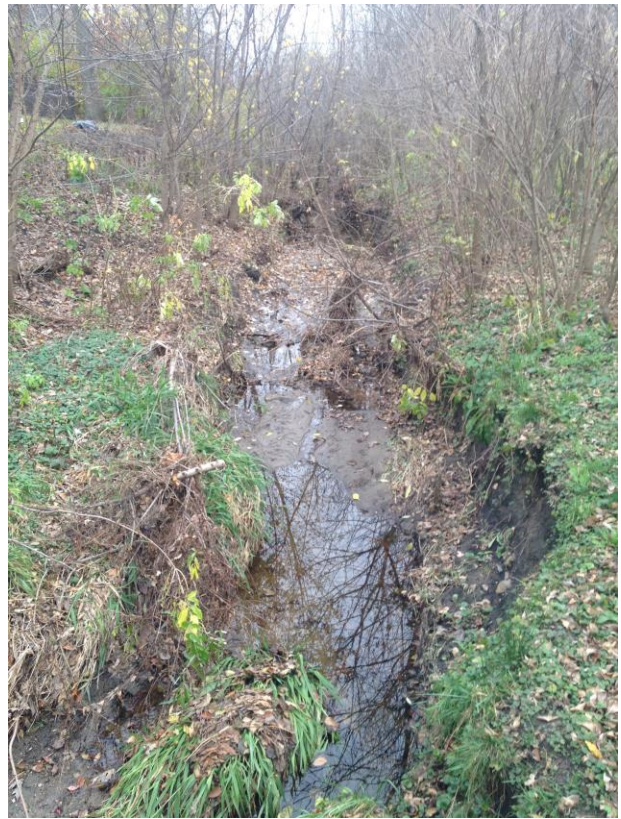
*Channel degradation upstream of Hoover Avenue/Edgewater Drive.*

As noted earlier in the memorandum, there are areas throughout the entire channel that are showing greater signs of erosion. There is an area between Kinyon-Clark Subdivision and Stone Brooke Subdivision that is lacking channel armoring, although no major erosion is occurring in this area. The areas upstream of Hoover Avenue/Edgewater Drive look to be in greater need of stabilization. We did not look at this area in detail, but recommend that the City be cognizant of any erosion issues within this additional area.

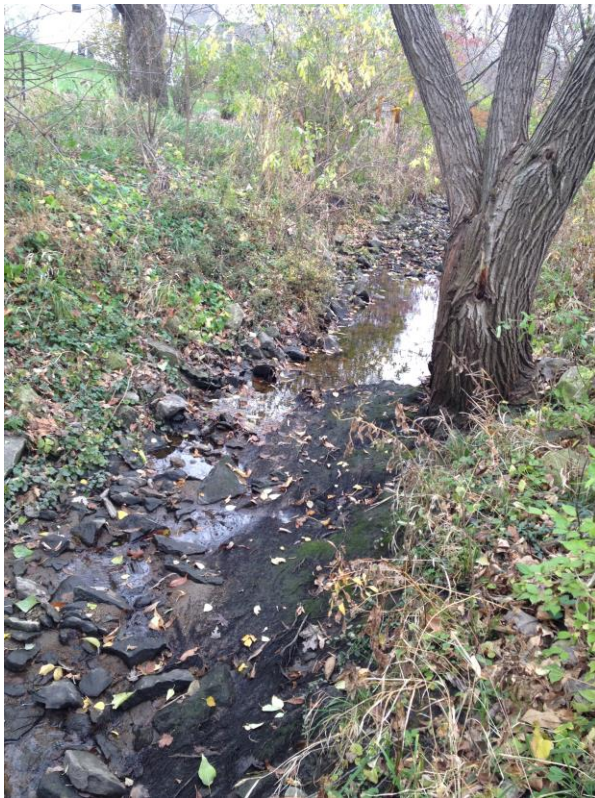
*Drainage channel through Stone Brooke Subdivision.*

The drainage channel through this area of the subdivision shows little evidence of significant erosion. There is sufficient channel armoring (Mr. Tedesco recalls the City had a contractor install the channel protection) along the sides of the channel in this area. In fact, some sediment is settling into the rip-rap armoring in some areas. We found no major bank erosion in this area that would lead to a settlement issue (undercutting or surface). In fact, this stretch of drainage channel is one of the better looking drainage channels throughout the City.

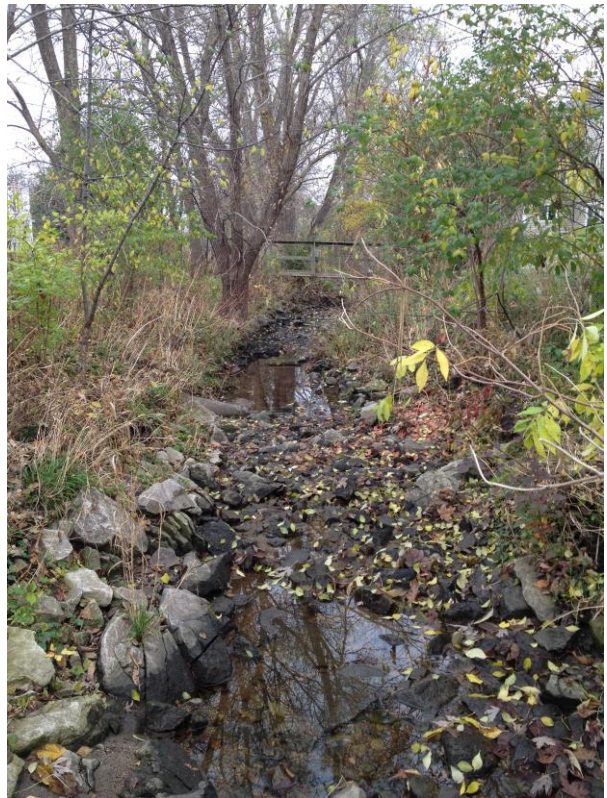
*Drainage channel through Stone Brooke Subdivision, near Mr. Tedesco's property.*

The main area of concern for these property owners is that their land is settling. They weren't sure why, but the elevation in their backyards continues to settle. Along Mr. Tedesco's property, there is a storm sewer pipe that outlets into the drainage channel. The land settlement is occurring above/near the storm sewer pipe installation. There are many reasons why the land could be settling including surface erosion, side slope sloughing along the channel, channel undercutting, poor compaction of utility trenches, and others.

A likely culprit for the settlement is poor compaction above/near the storm sewer trench when the pipe was installed.

We recommend that a survey benchmark be established in the vicinity of Mr. Tedesco's property, and perform annual monitoring to determine the amount of settlement. One immediate solution would be to place additional topsoil in the area of concern, with reseeding/sodding of the disturbed area.

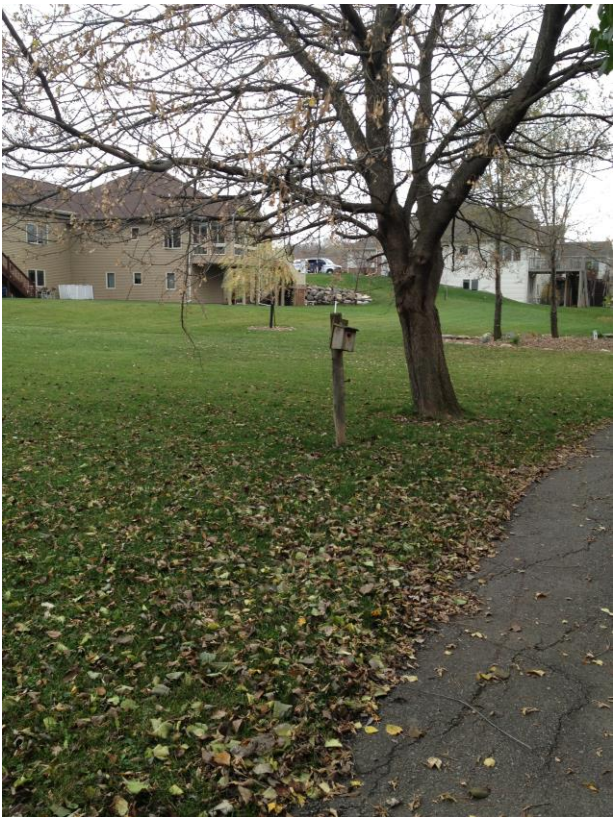
Although water outside of a main channel can be seen as a concern, it is actually imperative to have overflow areas in order to reduce erosion. The main channel through this area shows almost no signs of major erosion, except for some areas near woody vegetation. The channel in this area is generally acting as a two-stage channel. A two-stage channel is how a natural stream typically functions. In short, when storm water cannot be carried in the main channel, it overtops the banks into the low areas surrounding the main channel. This allows for more water to be carried within the stream corridor, and at a lower velocity, thus helping to reduce erosion. In other areas throughout town, the City has worked to re-create two-stage channels, including the College Creek Restoration project.

*Storm water overflow area.*

To our knowledge, the flooding described to us in the areas near Stone Brooke Subdivision is not damaging any permanent structures in the area. This 'flooding' allows for storm water in excess of the channel capacity to overtop and recede slowly, limiting erosion in the area. We feel that this area is could be a great educational tool to show residents how an urban channel can function well with surrounding uses.

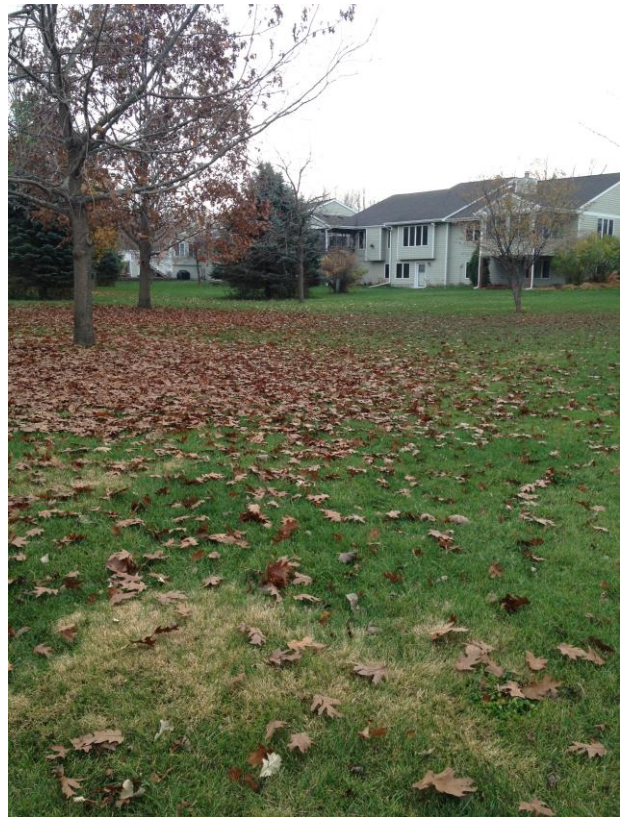
*Storm water overflow area.*

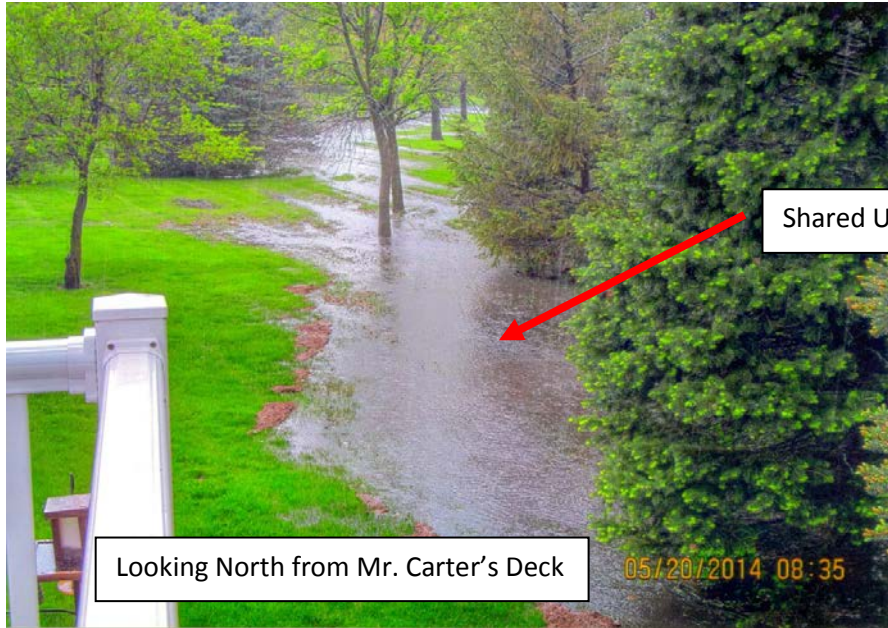
Shared Use Path Under Water

Looking North from Mr. Carter's Deck

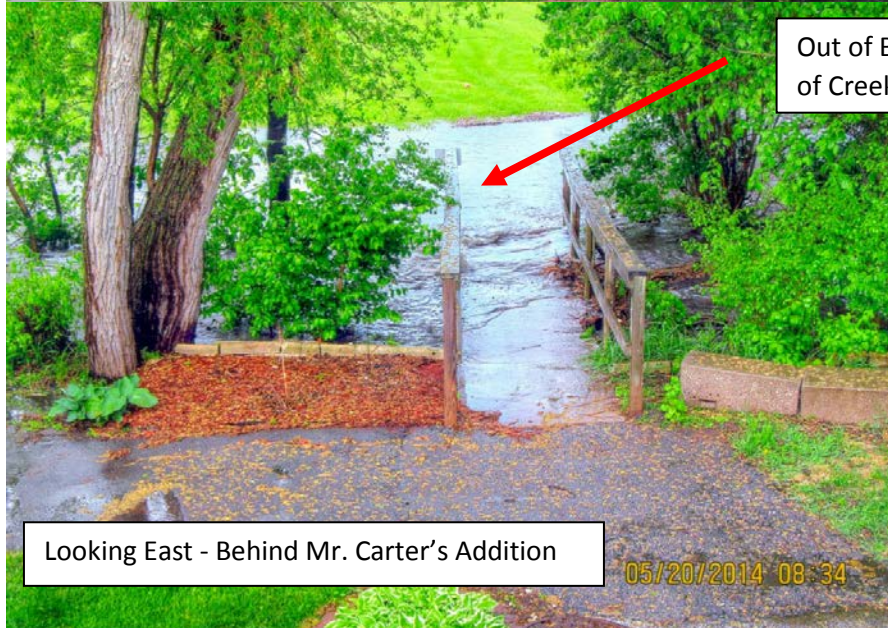
Out of Bank Flows on East Side of Creek and Over Bridge

Looking East - Behind Mr. Carter's Addition

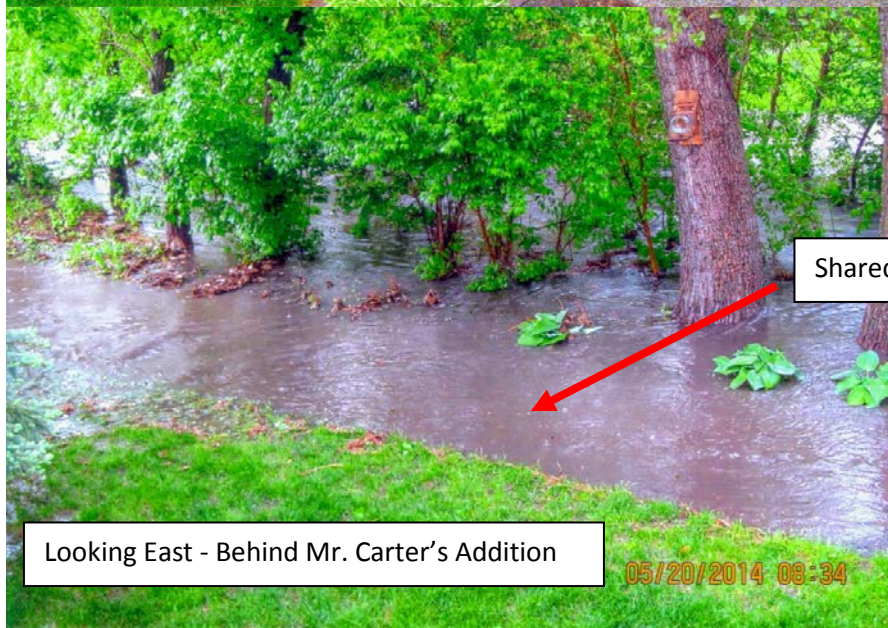
Shared Use Path Under Water

Looking East - Behind Mr. Carter's Addition

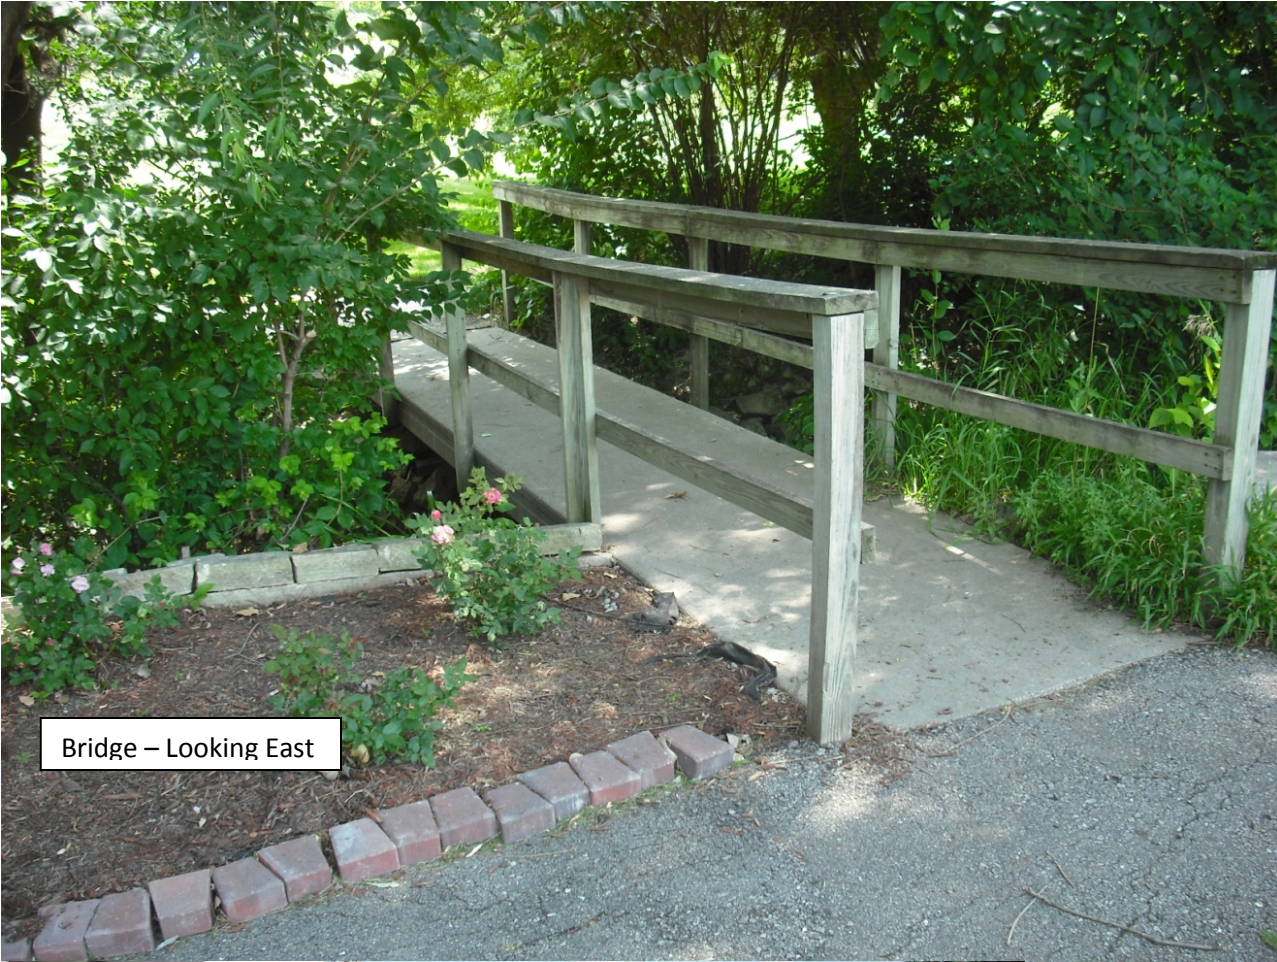
Bridge – Looking East

So far this year, the ditch has overflowed four times. There is a concrete bridge crossing the ditch behind our property and with a two inch rain, water flows over the bridge and is causing some serious erosion. A few years back, the bridge was jacked up and supported with a large rock base. This is now washing away and the bridge has dropped about an inch and has created a tripping hazard.

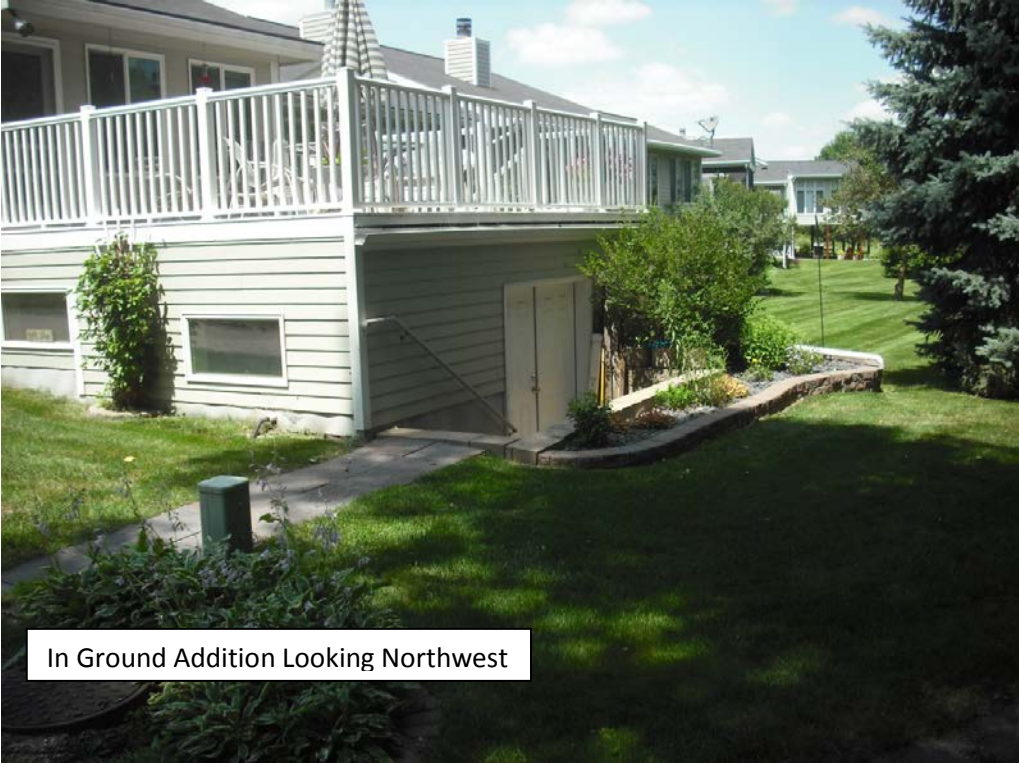
In Ground Addition Looking Northwest

Mr. Carter bought his home in 2005 and constructed a below grade addition in late 2005/early 2006 on the property line adjacent to an area designed and designated for storm sewer and surface water flowage. The addition sits within 30 feet of the existing creek channel where normal water elevations are roughly the same elevation as the bottom of his addition.
