**COUNCIL ACTION FORM**

**SUBJECT: PRELIMINARY PLAT FOR CORNER OF SE 16<sup>TH</sup> STREET AND S DAYTON AVENUE AT 1499 S DAYTON AVENUE.**

Wheelock Corner Subdivision  
Preliminary Plat

# Natural Resources Inventory

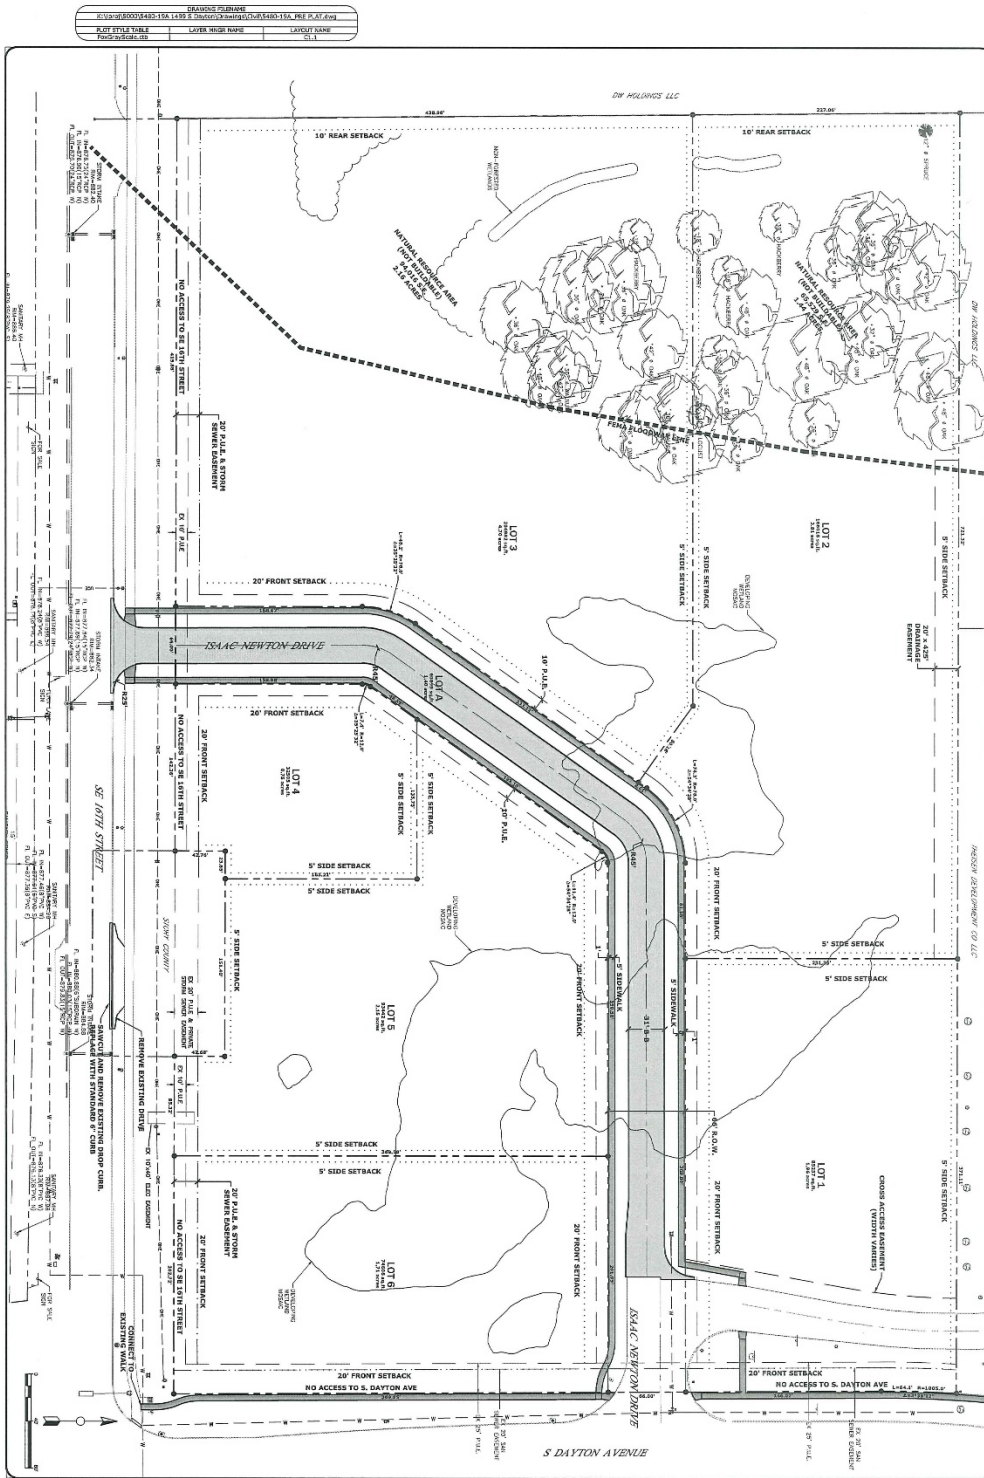
ATTACHMENT B: PRELIMINARY PLAT LOT LAYOUT

<p>DATE: 03/05/09</p> <p>BY: SIK</p> <p>CHECKED: JMK</p> <p>DESIGNED: JMK</p> <p>DECISION: 03/05/09</p> <p>LAST UPDATE: 03/04/09</p>	<table border="0"> <tr> <td style="vertical-align: top;"> <p>LOT LAYOUT &amp; DIMENSIONING PLAN WHEELOCK CORNER SUBDIVISION</p> <p>1499 S. DAYTON AVE AMES, IA</p> </td> <td style="text-align: center; vertical-align: middle;"> </td> <td style="vertical-align: top;"> <p>FOX Engineering Associates, Inc. 414 South 17th Street, Suite 107 Ames, Iowa 50010 Phone: (515) 233-0000 Fax: (515) 233-0100</p> </td> </tr> </table>	<p>LOT LAYOUT &amp; DIMENSIONING PLAN WHEELOCK CORNER SUBDIVISION</p> <p>1499 S. DAYTON AVE AMES, IA</p>		<p>FOX Engineering Associates, Inc. 414 South 17th Street, Suite 107 Ames, Iowa 50010 Phone: (515) 233-0000 Fax: (515) 233-0100</p>	<p>C1.1</p>
<p>LOT LAYOUT &amp; DIMENSIONING PLAN WHEELOCK CORNER SUBDIVISION</p> <p>1499 S. DAYTON AVE AMES, IA</p>		<p>FOX Engineering Associates, Inc. 414 South 17th Street, Suite 107 Ames, Iowa 50010 Phone: (515) 233-0000 Fax: (515) 233-0100</p>

Wheelock Corner Subdivision is a proposed 16.47-acre development on the northwest corner of the intersection at SE 16<sup>th</sup> Street and S Dayton Avenue. See a location map in Attachment A. The property owner, DW Holdings, LLC., requests approval of a preliminary plat creating 6 lots. There are six developable parcels and proposed public – right-way, Isaac Newton Drive, that will provide access throughout the development. (Lot Layout-Attachment B)

All six lots will have access off of the newly extended Isaac Newton Drive. Direct access to SE 16<sup>th</sup> Street and S Dayton Avenue will be prohibited. Shared access to the Theisen’s will also remain.

The proposed preliminary plat will yield six developable lots. The lot sizes range from .75 acres to 4.70 acres. The approximate western half of Lots 2 and 3 will not be developable since they are located within the Environmentally Sensitive Overlay District. Note that by having this area as part of the individual lots rather than as a separate outlot, it allows for calculation of development standards for floor area ratio to occur across the gross lot area, therefore allowing for more development potential in relation to floor area ratio limitations.

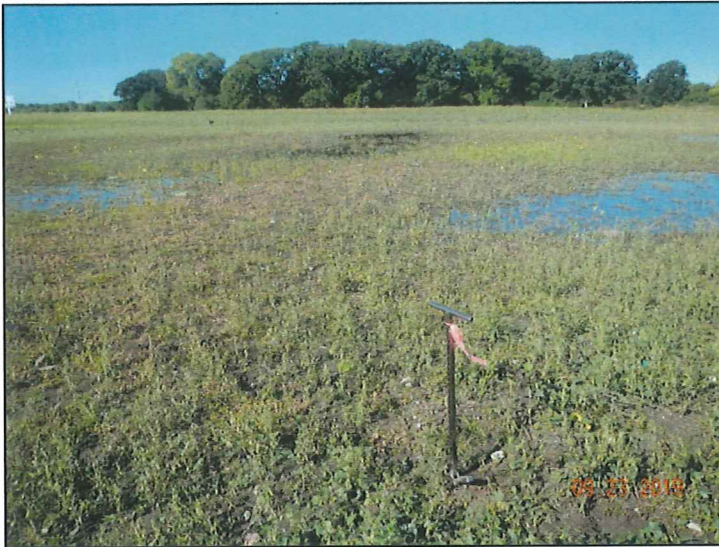
**Photo 1: Developing Wetland Mosaic**  
Data Point: Fox-01  
Date: 9/23/2019  
Direction: West

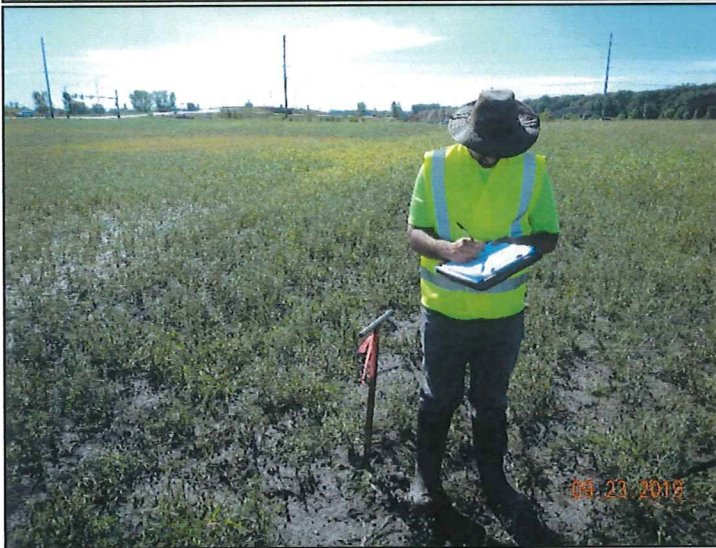
**Photo 2: Upland Crop Field**  
Data Point: Fox-02  
Date: 9/23/2019  
Direction: South

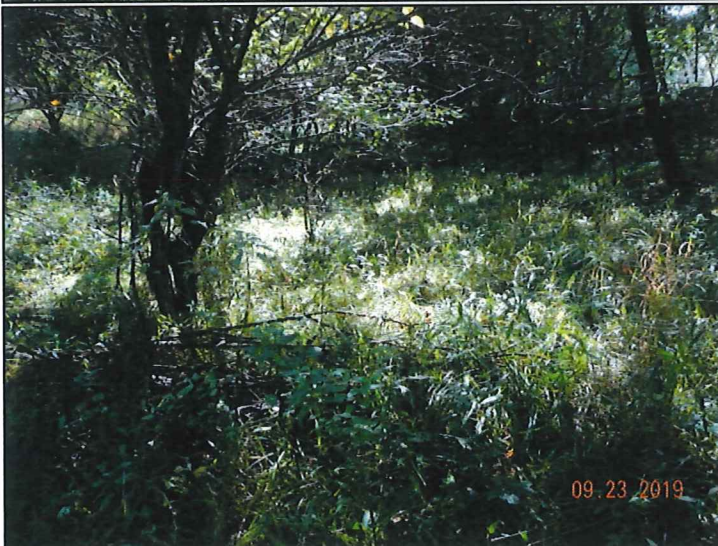
**Photo 3: Upland - Old Stream Channel**  
Data Point: Fox-03  
Date: 9/23/2019  
Direction: North

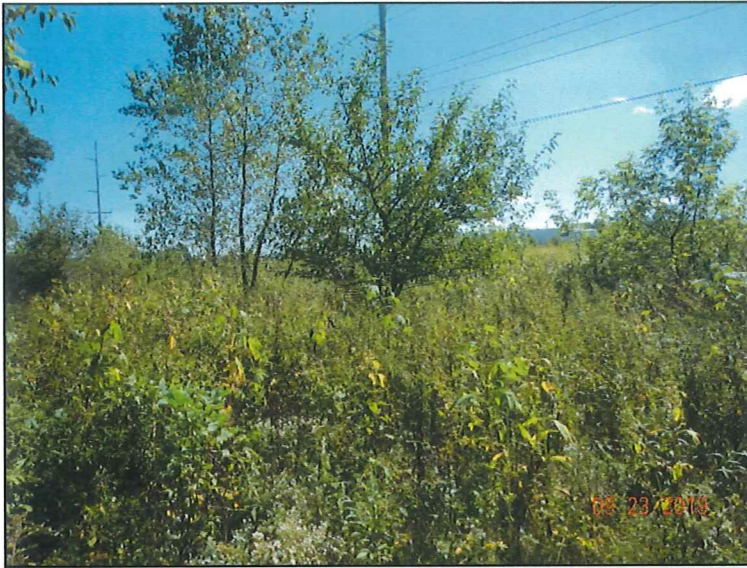
**Photo 4: Non Forested Wetland**

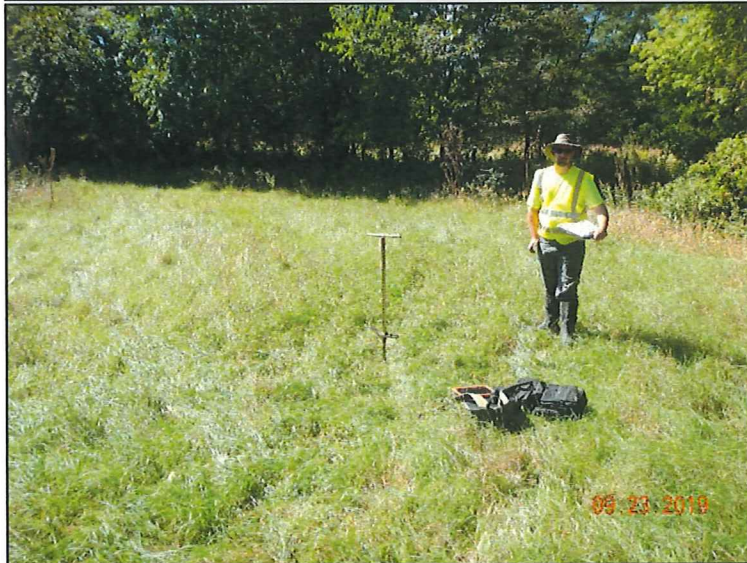
**Photo 5: Upland - Old Stream Channel**

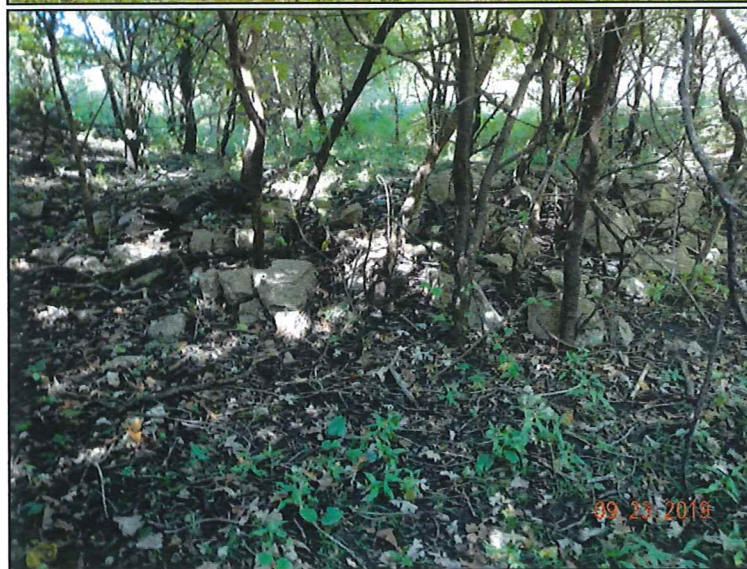
**Photo 6: Non Forested Wetland**

Direction: North - At northern edge of wetland area. Old rubble and fill material located north of data point.

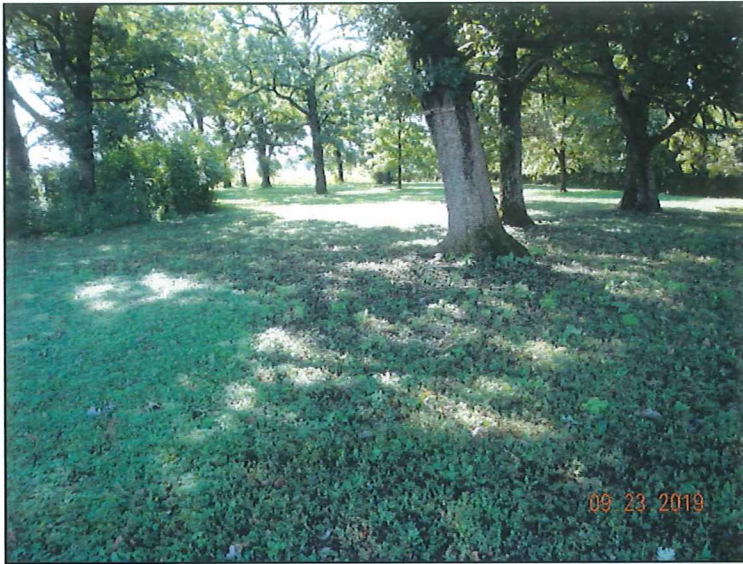
**Photo 7: Oak Woodland**

Direction: South - Taken near edge of NFHL mapped floodway.

- **Woodland:** No impact; resources avoided.
  - Woodlands<sup>7</sup> present within the project vicinity will not be impacted by development activities. No trees in woodland areas will be removed. Grading and equipment operation will occur outside the drip line of woodland canopies to the greatest extent possible to prevent incidental damage to the trees' roots.

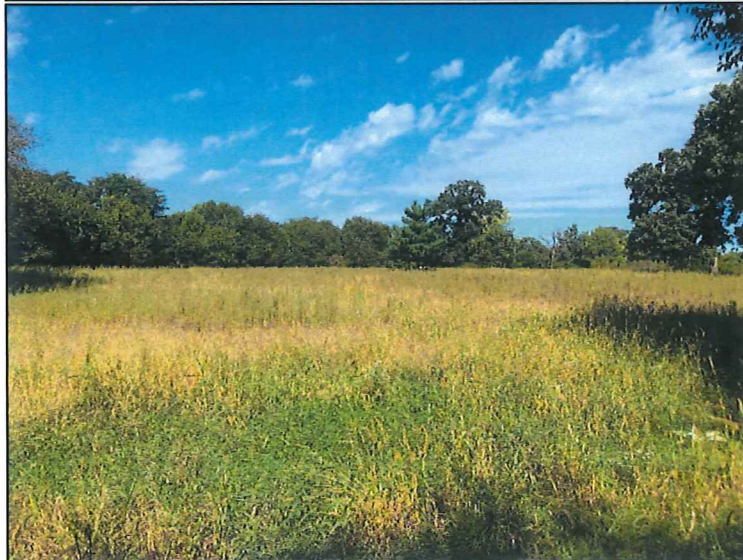
**Photo 8: Upland - Old Field**
