To: Mayor and City Council
From: Keith Abraham, Parks and Recreation Director
Date: May 5, 2023
Subject: Existing Buildings on the Sands-McDorman Property

BUILDING EVALUATION:

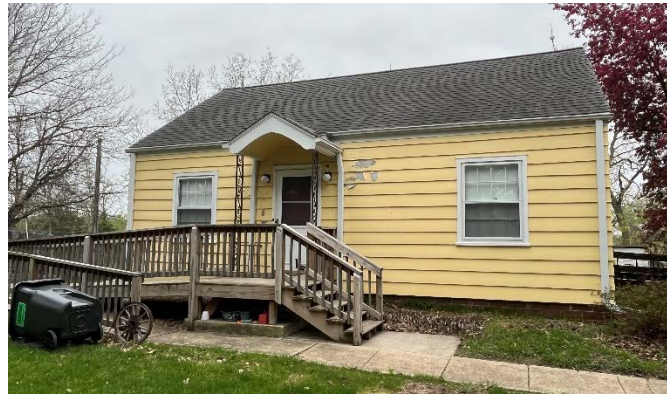
#1 House:

Overall, the house is in good shape for the age of the structure. To change the use of this building from residential to commercial or business use would require some modifications such as accessible entrances, bathrooms, parking and perhaps even some structural reinforcement. Consultation with an architect is recommended to determine the feasibility of reusing this structure for anything other than residential uses.

The visual inspection indicates the garage and milk house could be used for storage after improvements are made. Further inspection of the house by an architect would need to be performed to determine what needs to be done to make the house compliant for commercial use.

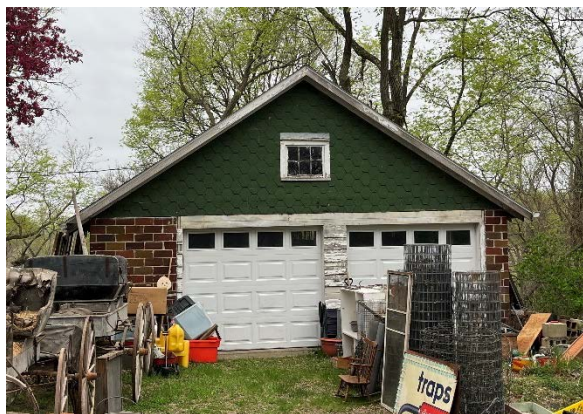
#2 Garage:

This building seems structurally sound from visual inspection. The foundation and roof system are in average shape for the age of the building. The roof should be replaced, and some tuckpointing/brick work would need to be done to make the structure weather tight. With those improvements, the building could then be used for storage.

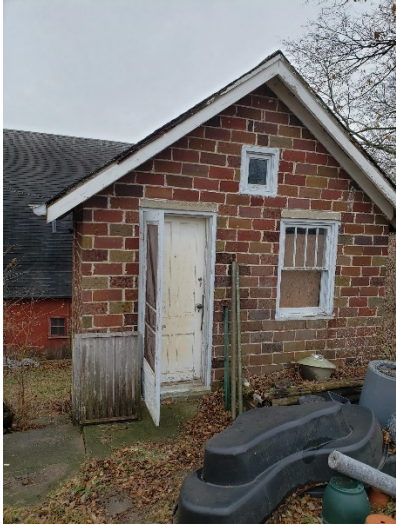
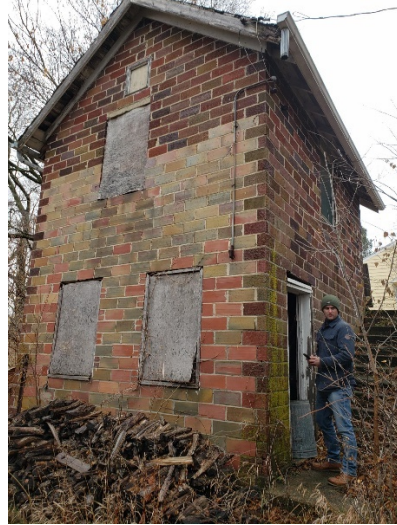
#3 Milk House:

This structure is in good shape for the age of the building. It does need some ceiling joist repair/replacement on the top floor, a new roof, tuckpointing/brick work, and new windows to seal the building against the elements. This building could be used as storage, similar to the garage.

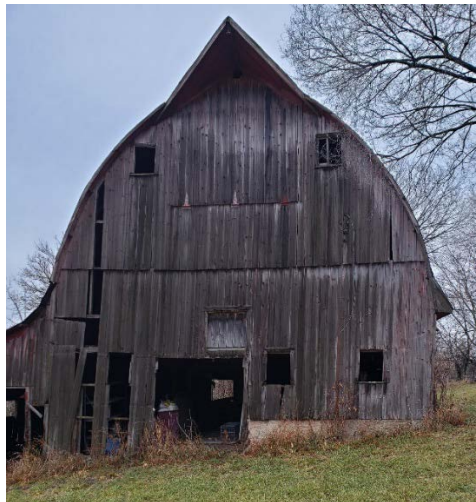
#4 Large Barn:

This building is structurally unsafe due to several factors. It is substantially leaning to the west and the interior load bearing elements are not properly supported. The foundation of this structure is in bad condition as well. It is recommended that this building not be used for storage or occupancy in its current condition. However, there is some value in the old lumber.

Staff would recommend: 1) soliciting buyers for the barn wood, as there is value in the lumber, and 2) demolishing the remaining buildings once the purchase of the property is complete.

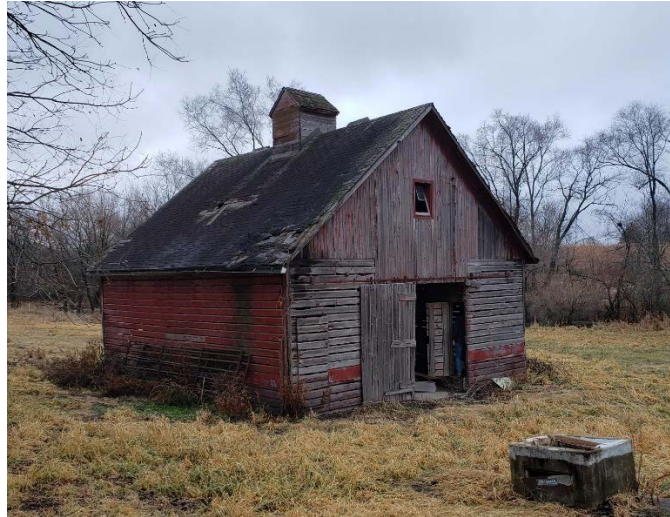
#5 Small Barn / Corn Crib:

The foundation of the building is below average with some noticeable cracking under the load bearing walls. The roof structure seems inadequate due to rotting wood members. This building should not be used in its current condition but has value in the lumber, same as the Large Barn.
