SUBJECT: LINCOLN WAY PEDESTRIAN STUDY (REPORT ON PHASE 1, AUTHORIZE PHASE 2)

Lincoln Way Multimodal Crossing Data Collection and Analysis

Phase 1 – Discovery and Findings

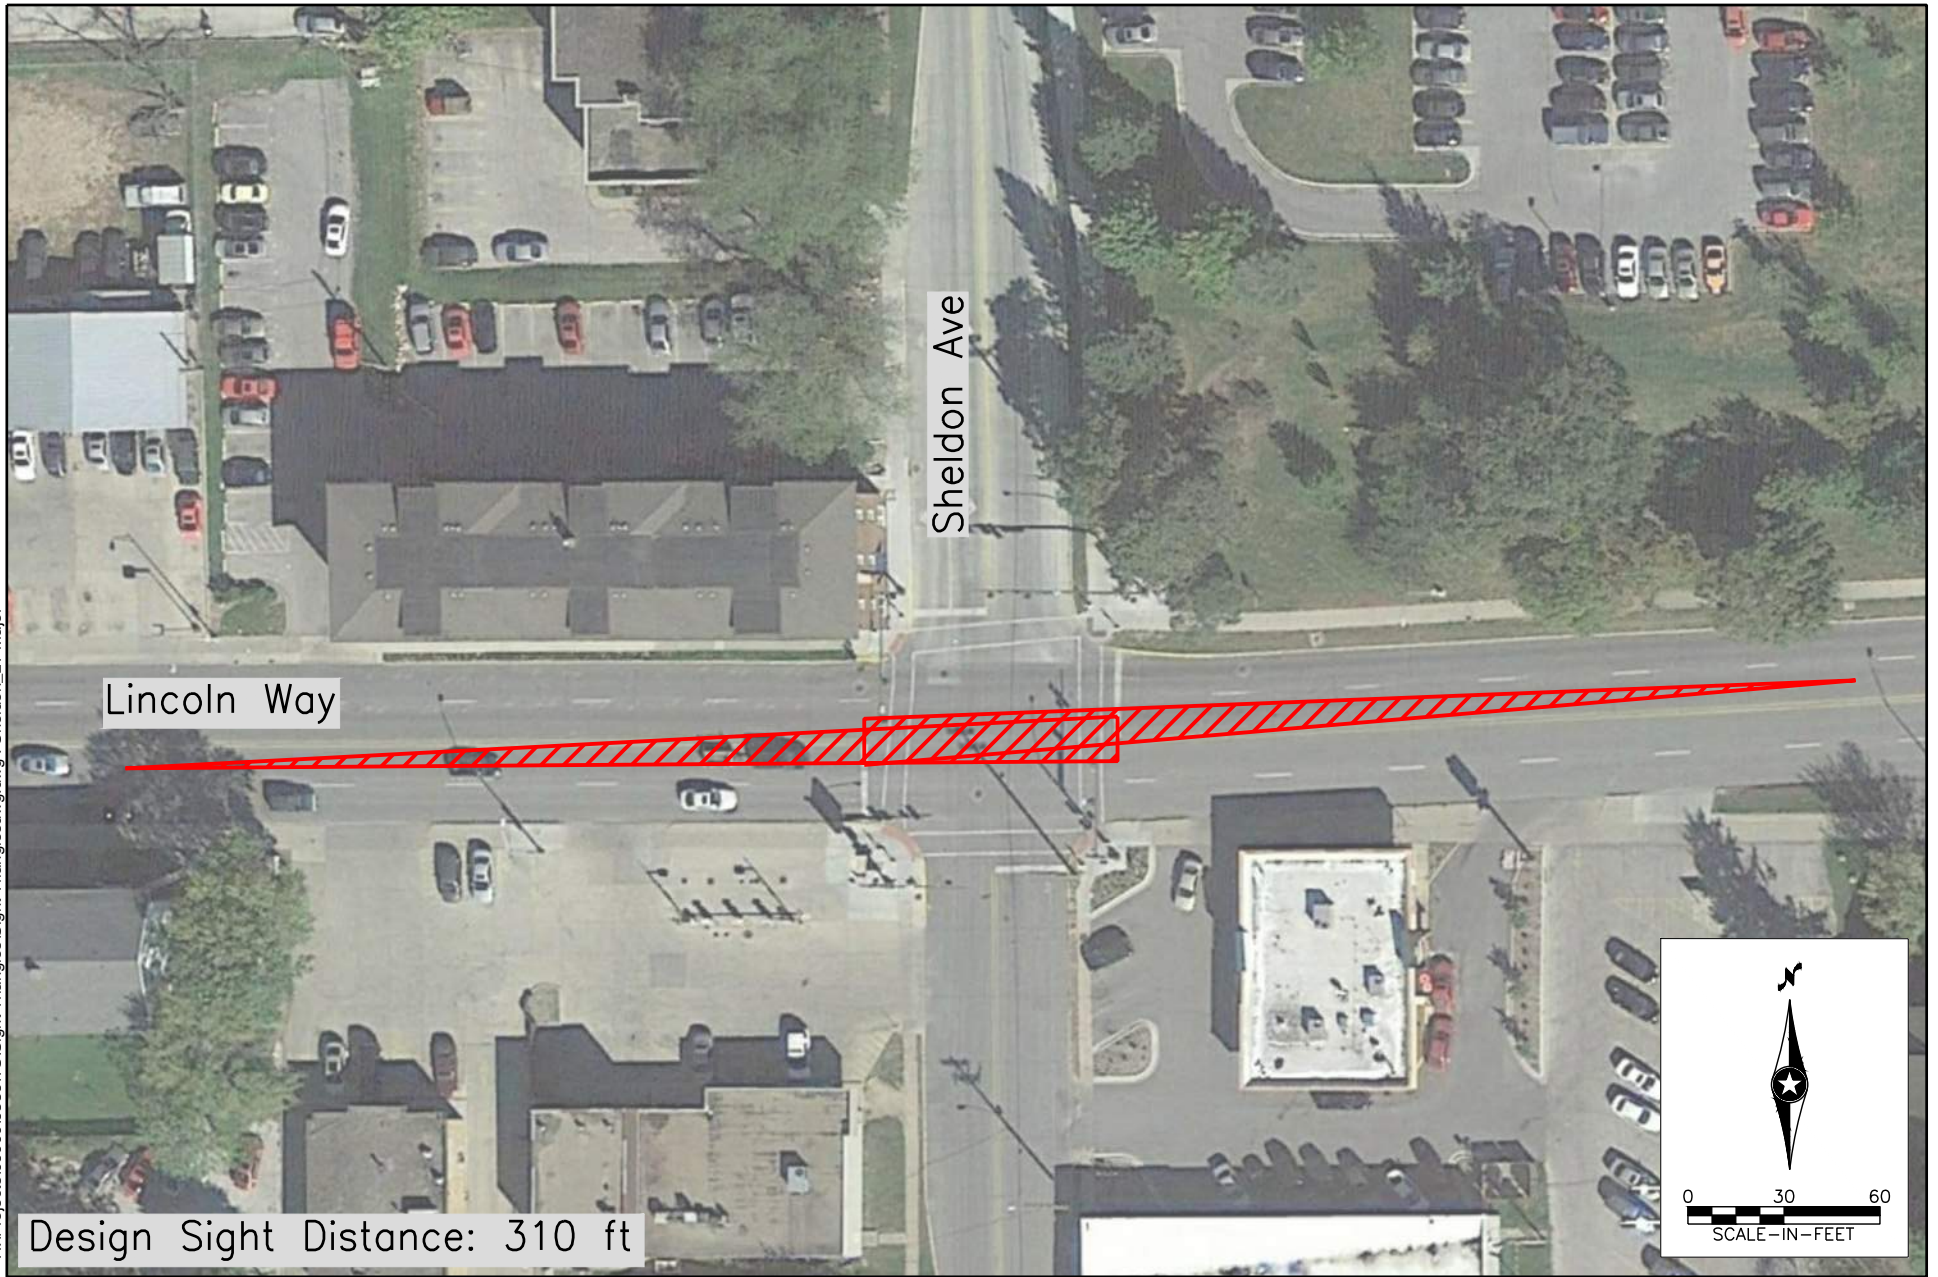
Figure 1

Lincoln Way & Sheldon Ave Sight Triangles: Left-Turn from Major Approach
Lincoln Way Safety and Operations Study
Ames, Iowa

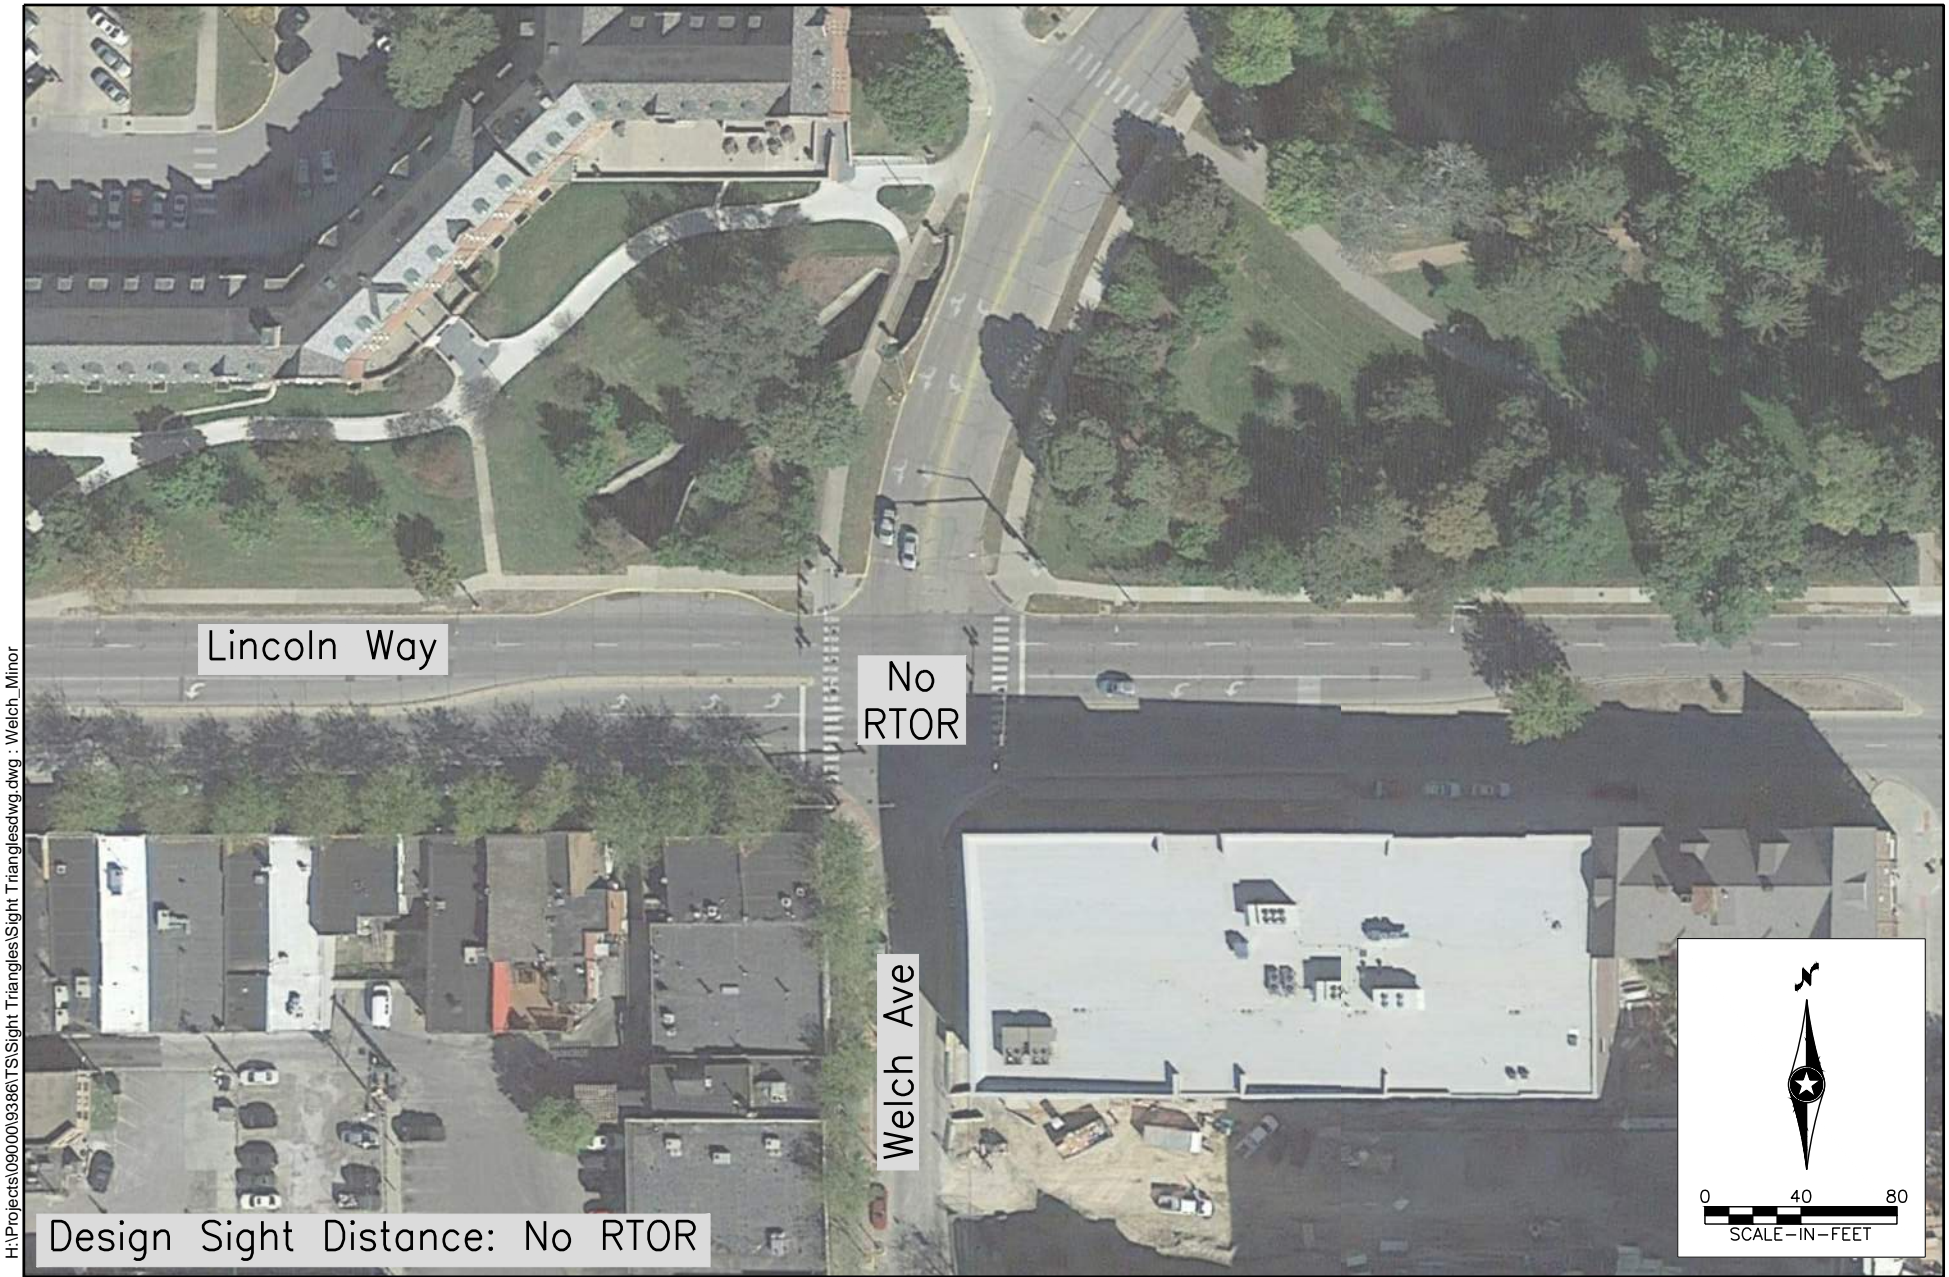
Figure 6

Lincoln Way & Welch Ave Sight Triangles: Left-Turn from Major Approach
Lincoln Way Safety and Operations Study
Ames, Iowa

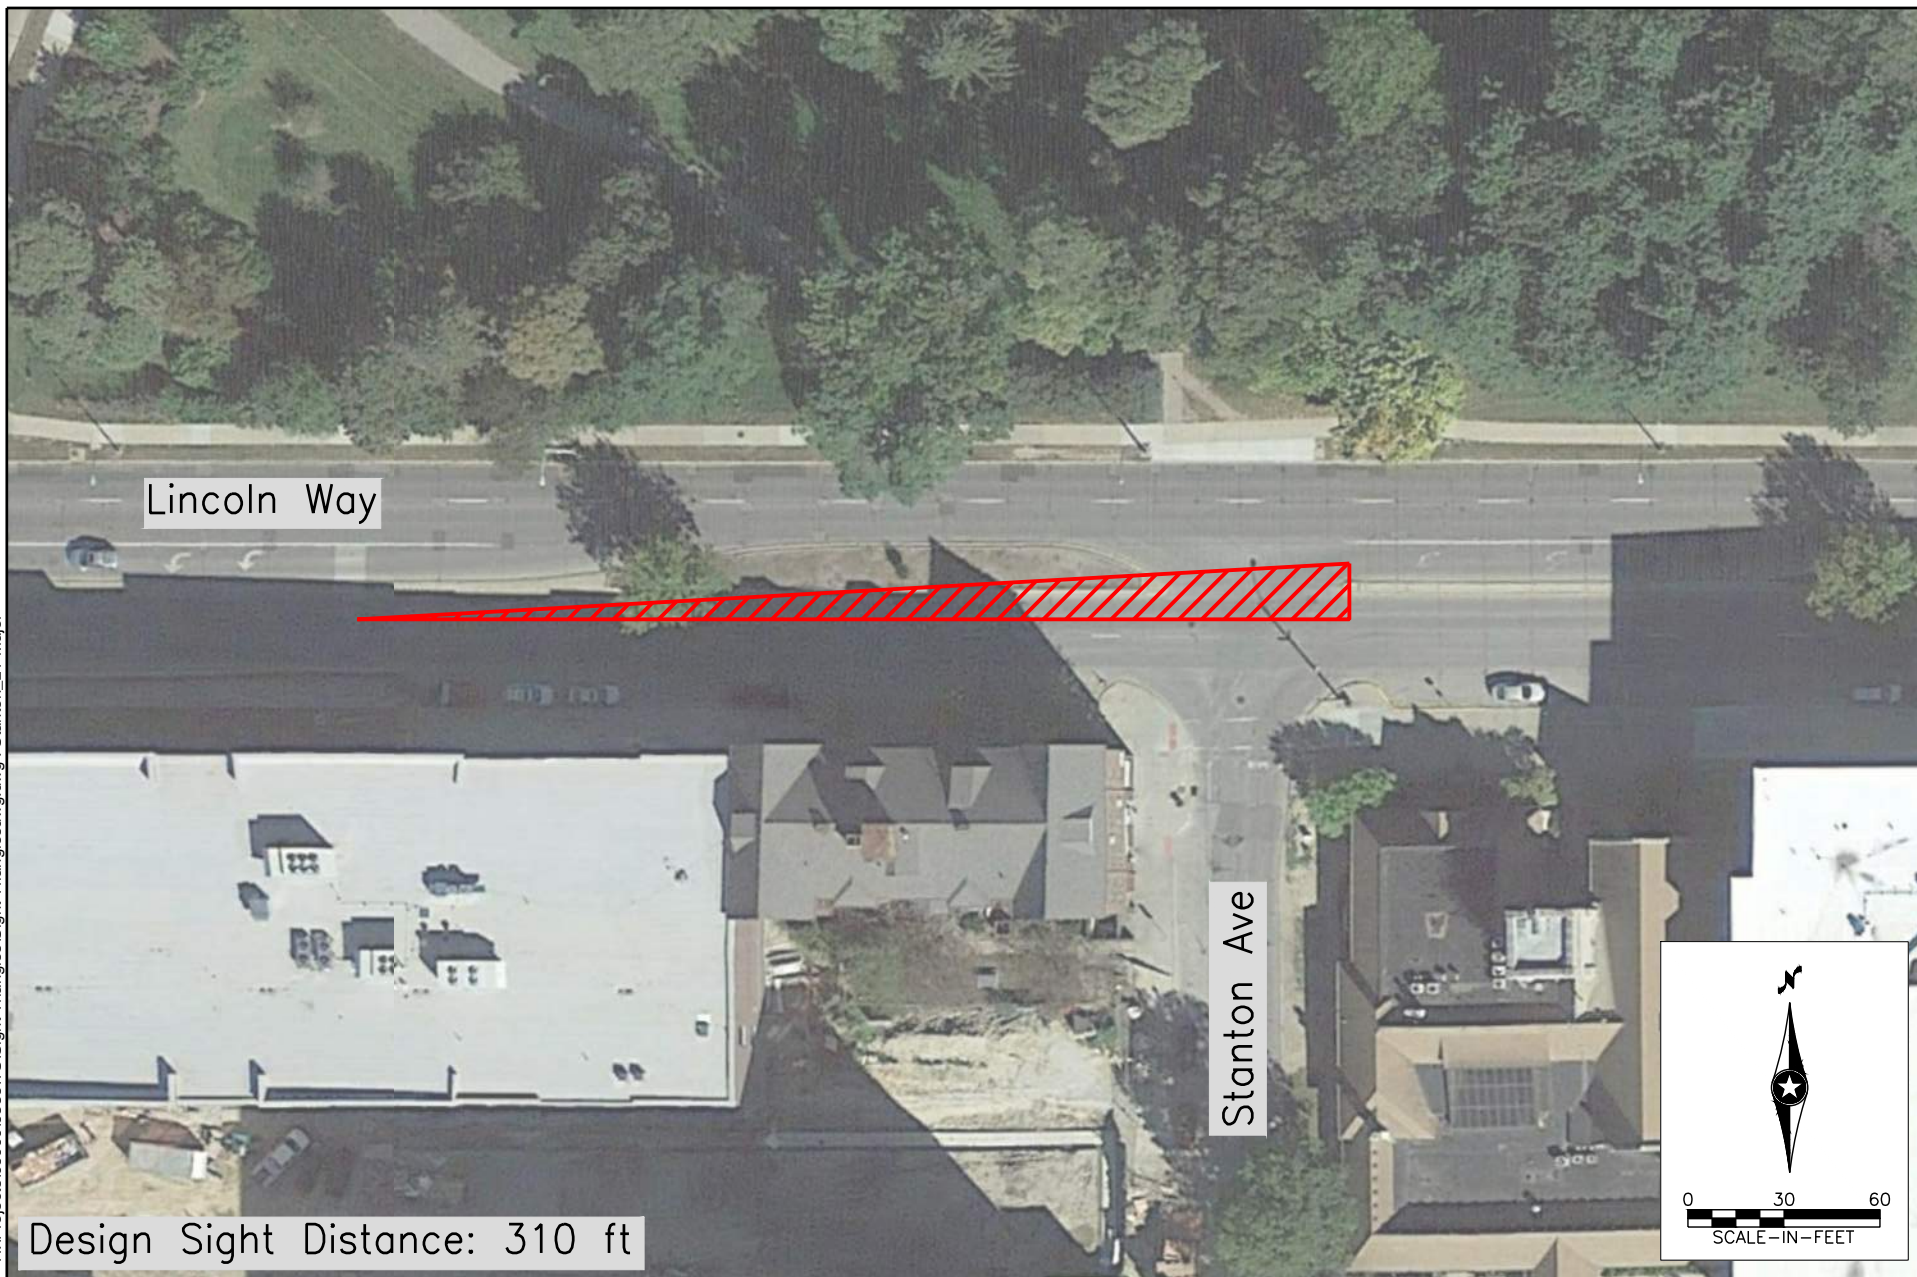
Figure 8

Lincoln Way & Stanton Ave Sight Triangles: Left-Turn from Major Approach
Lincoln Way Safety and Operations Study
Ames, Iowa

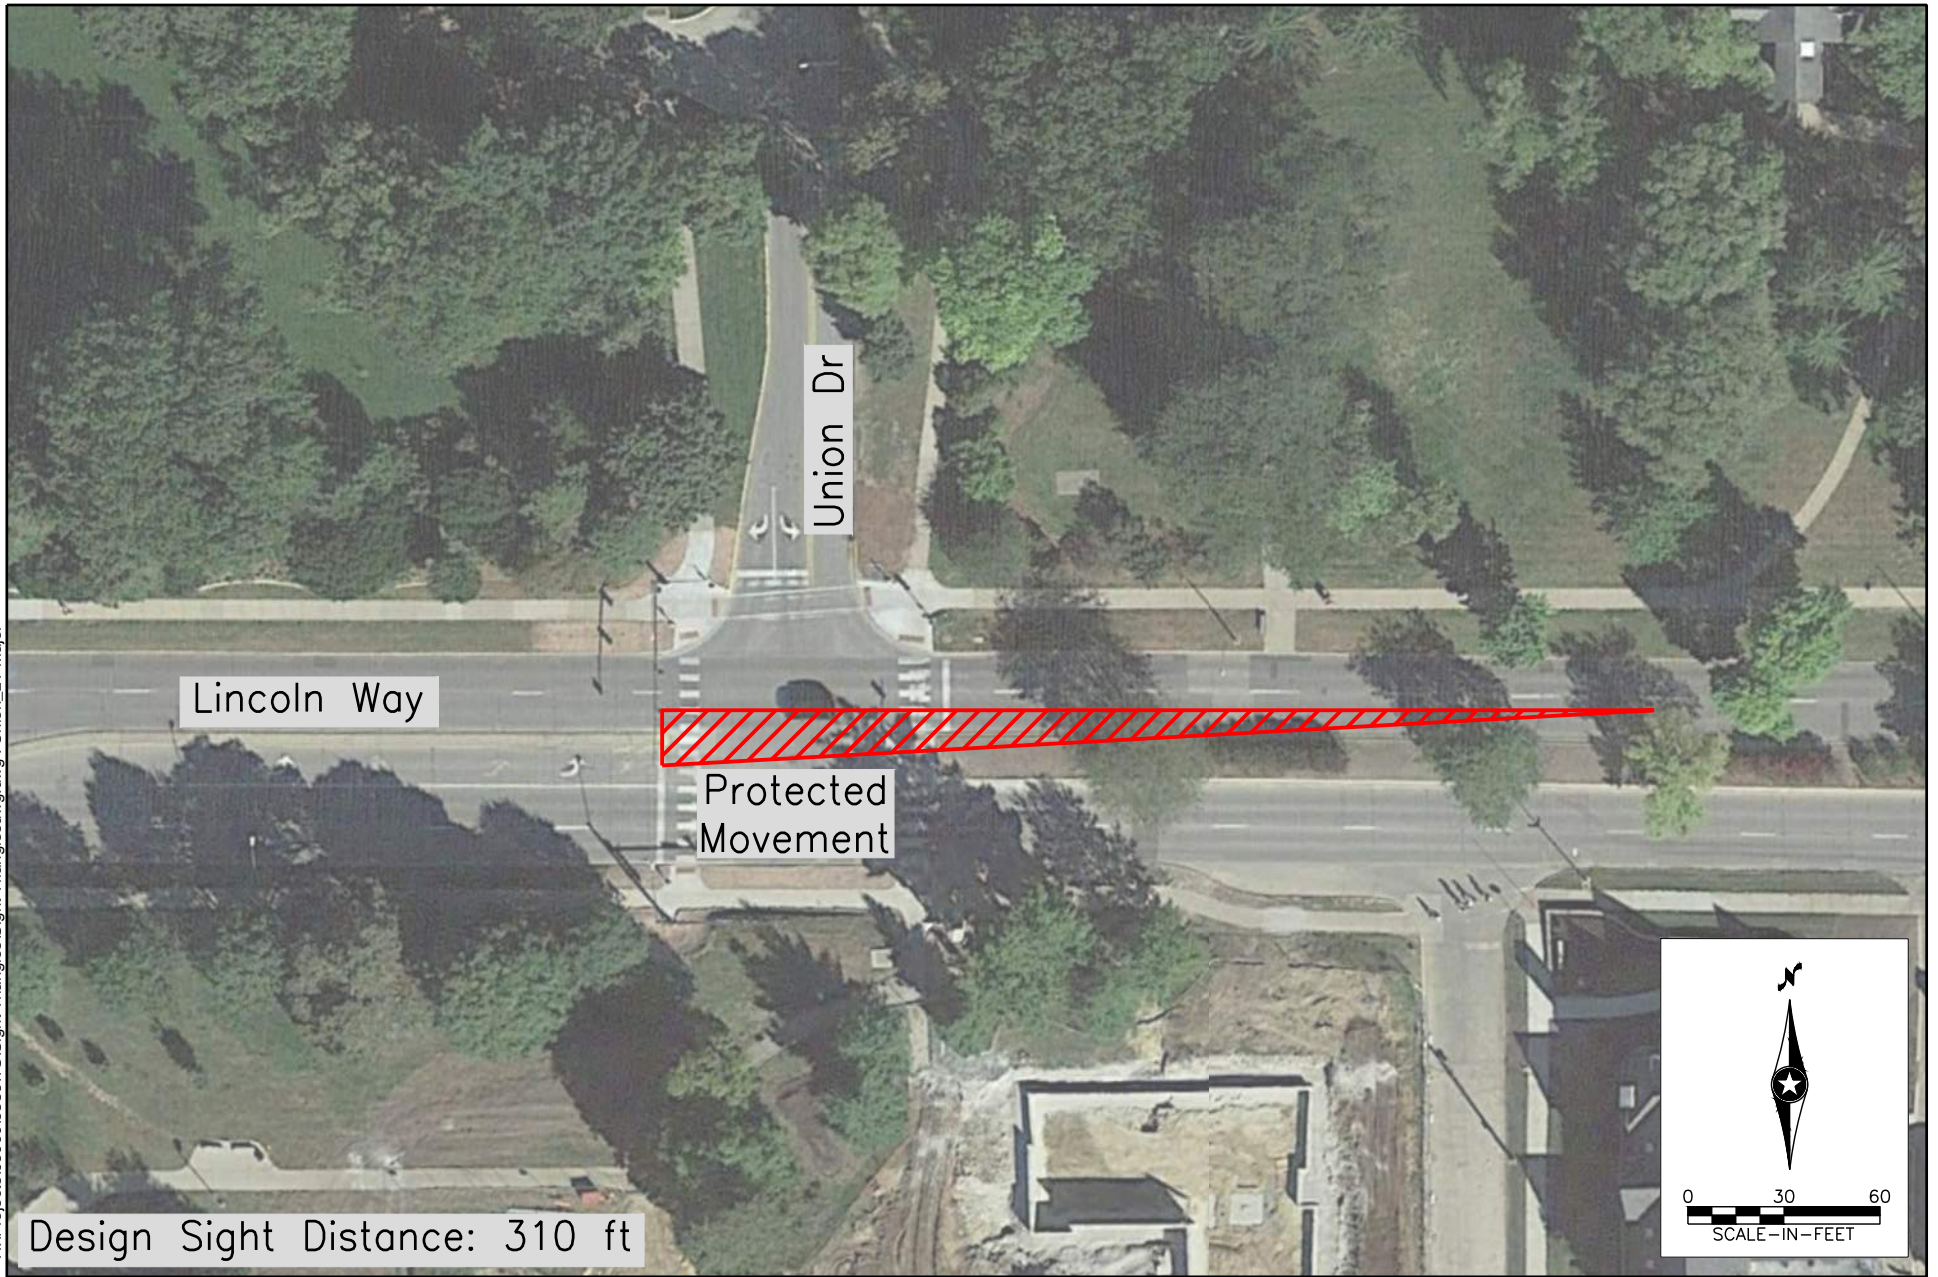
Figure 15

Lincoln Way & Union Dr Sight Triangles: Left-Turn from Major Approach
Lincoln Way Safety and Operations Study
Ames, Iowa
