**From:** Ravenscroft, Sue P [ACCT] <sueraven@iastate.edu>  
**Sent:** Thursday, September 22, 2022 2:26 PM  
**To:** Abraham, Keith  
**Cc:** City Council and Mayor  
**Subject:** Request for Capital Improvement Plan consideration

I am writing to request that the City of Ames Parks and Recreation Department consider adding an item to its CIP related to recreational facilities - removal of the stone "bridges" in Clear Creek.

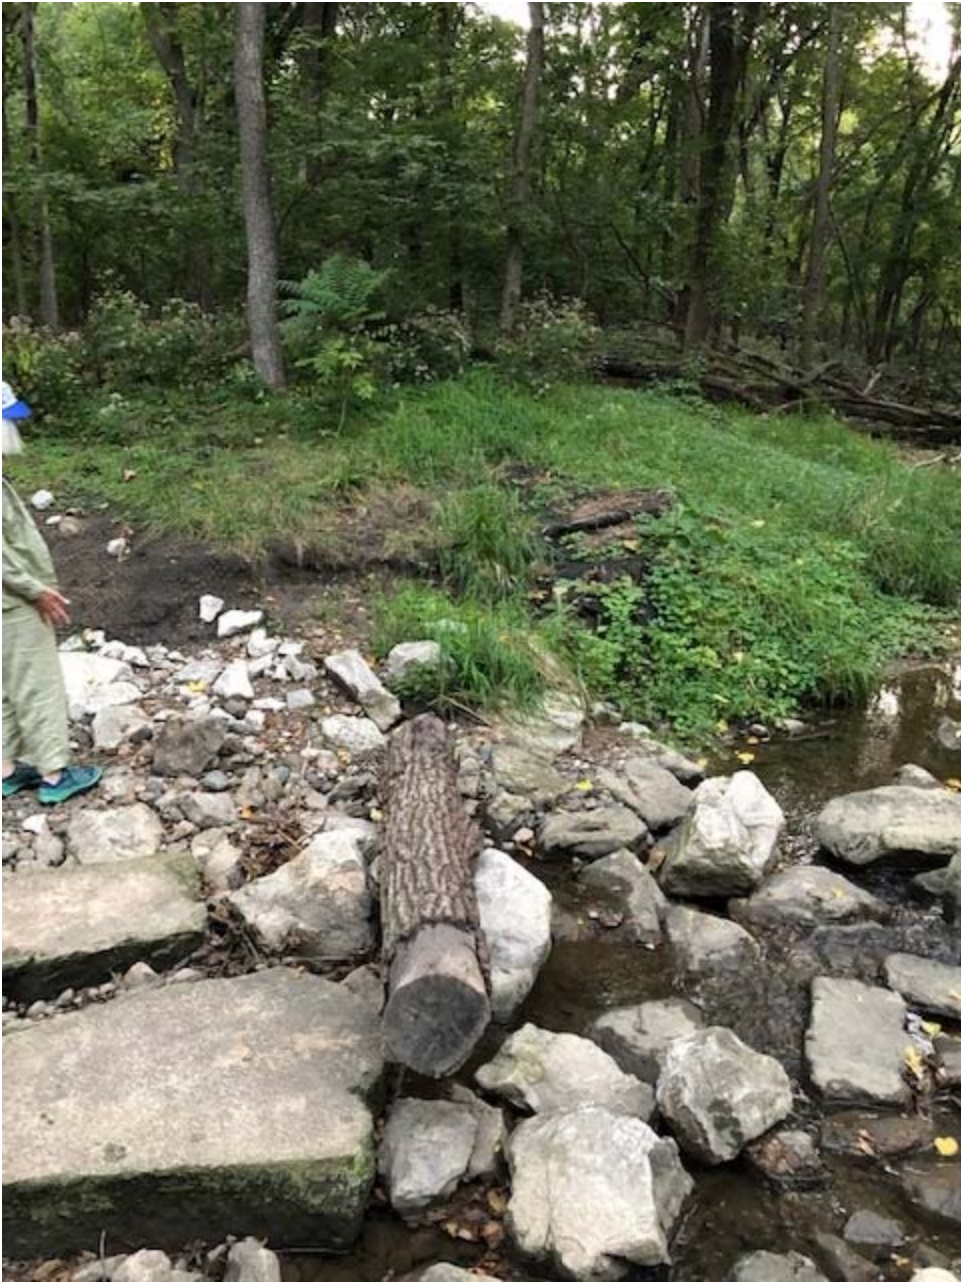
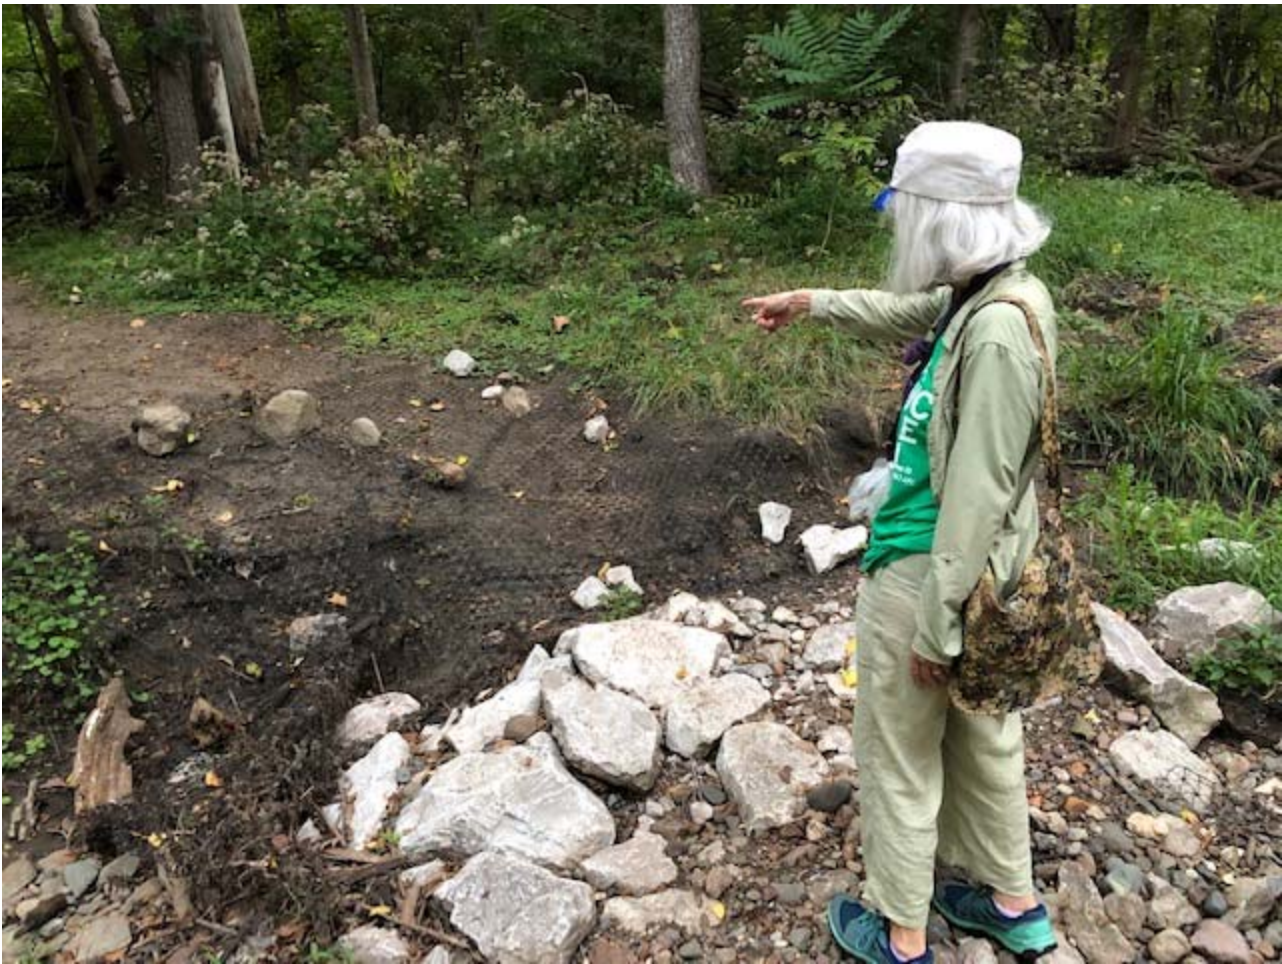
In early July of this year I walked it with a friend, and we both noted how awkward it was on the River right side (assuming I am looking downstream) because of the rocks the city had placed there. The rocks went down the inclined bank to the first big stone comprising the bridge and the big more or less rectangular stones went to the other bank of the creek and allowed for an easy step up to the bank. That was two months ago. Since built two years ago the bridge has been a funnel that caught branches and other things, and when I walked it I often would move branches and smaller stones around to help the water flow freely.

However, just this summer, on River Left a new channel between the last stone and the bank has opened up. That new channel was brought to your attention, and the city has moved stuff around, so the gap the channel created between the last stone and bank is now filled with rocks, mesh, silt, and branches that are very unstable and destined when we get a heavy rain to be moved downstream. In the first two pictures below I am standing where the last stone USED to be on River Left, and probably still is, but has been buried (in only two months) beneath all that detritus. This is not a stable situation; it is dangerous for pedestrians and requires frequent oversight by the city.

I would propose that the city have all those masses of rocks that interrupt the flow of the creek, which results in erosions of the banks as well as huge silt deposit build-ups within the creek, removed. By their nature, creeks and flowing bodies of water do not remain exactly the same, but the changes will be less extreme and less harmful to flora and fauna if those obstructions to the flow are removed. I would also propose that the city consult a hydrologist who understands woodlands to oversee any work done in this area.

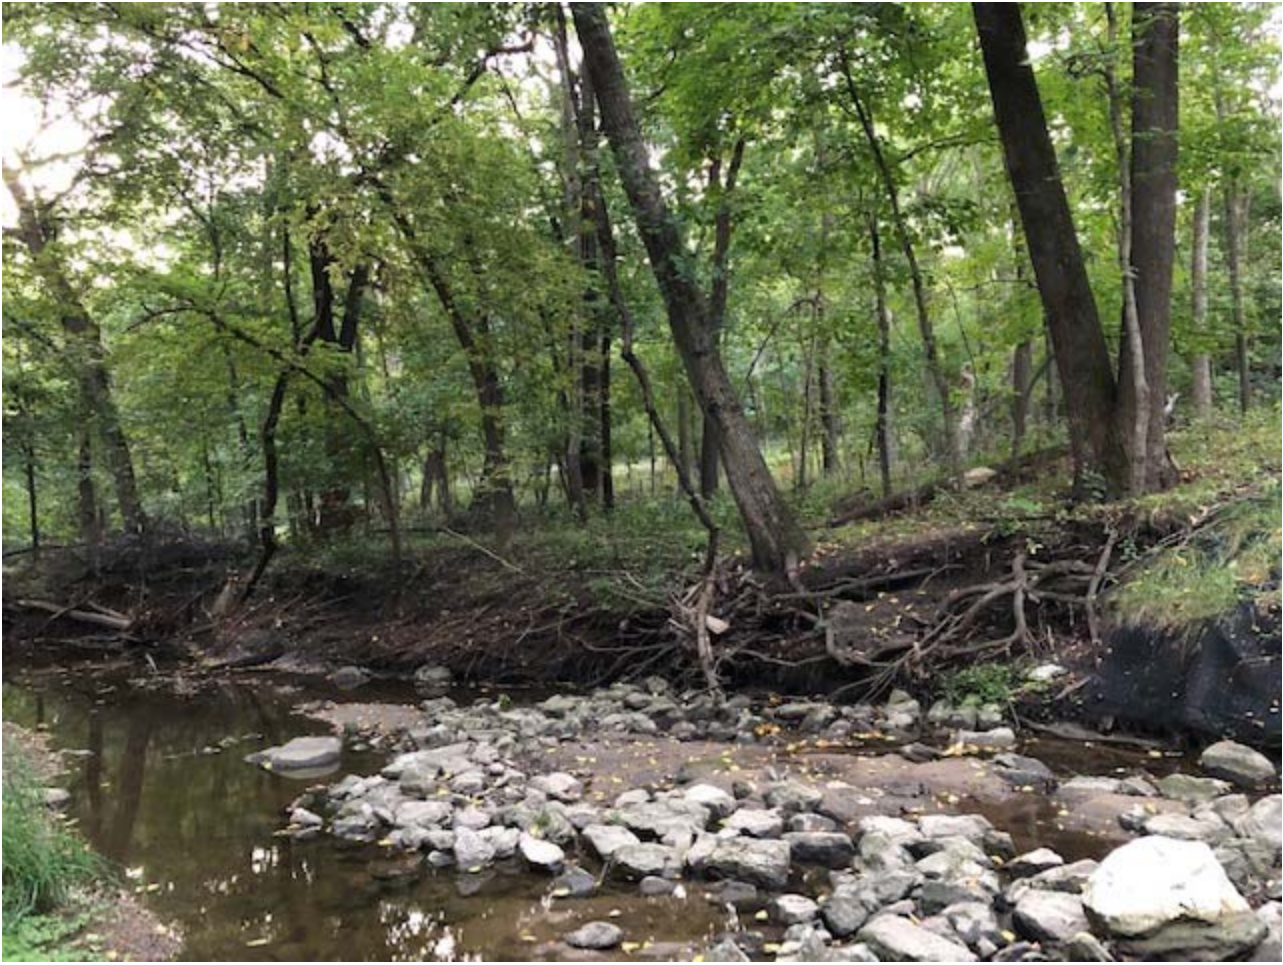
The next picture shows the River Right side of the creek immediately downstream of the bridge. You can see how eroded the River Right bank is already with tree roots seriously exposed, as well as the build-up of stones in the creek that serve no useful purpose.

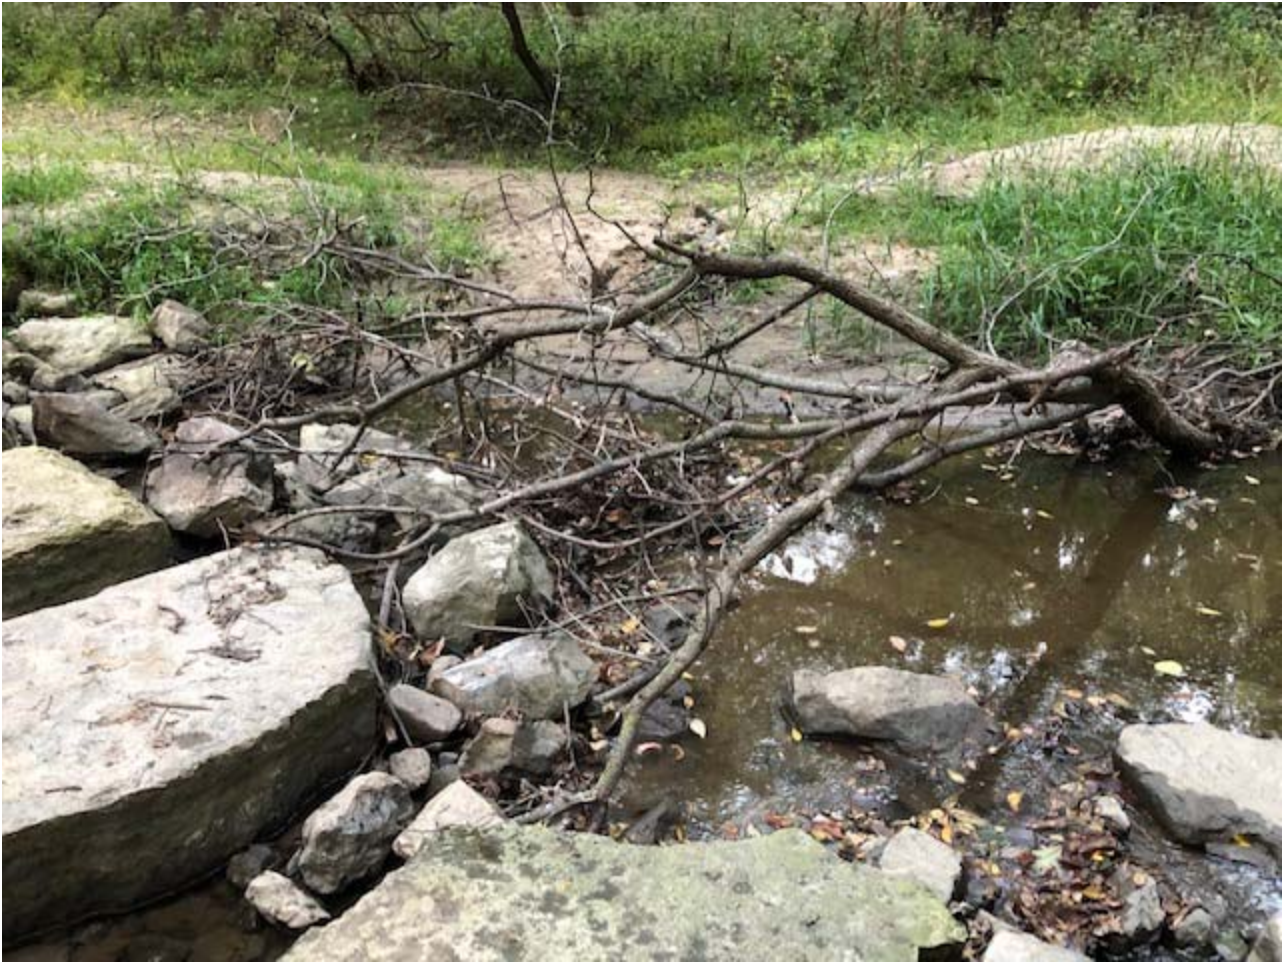
The fourth picture (immediately upstream of the bridge River Right) shows how much foliage gets caught in the bridge. The final picture shows the River Right side of the bridge. The rocks that were on the bank have been completely covered with silt, and the silt deposit has crept over the first stone in the bridge. What has happened very quickly that I could do nothing to ameliorate is a very large silt deposit on River Right just before (upstream of) the bridge.

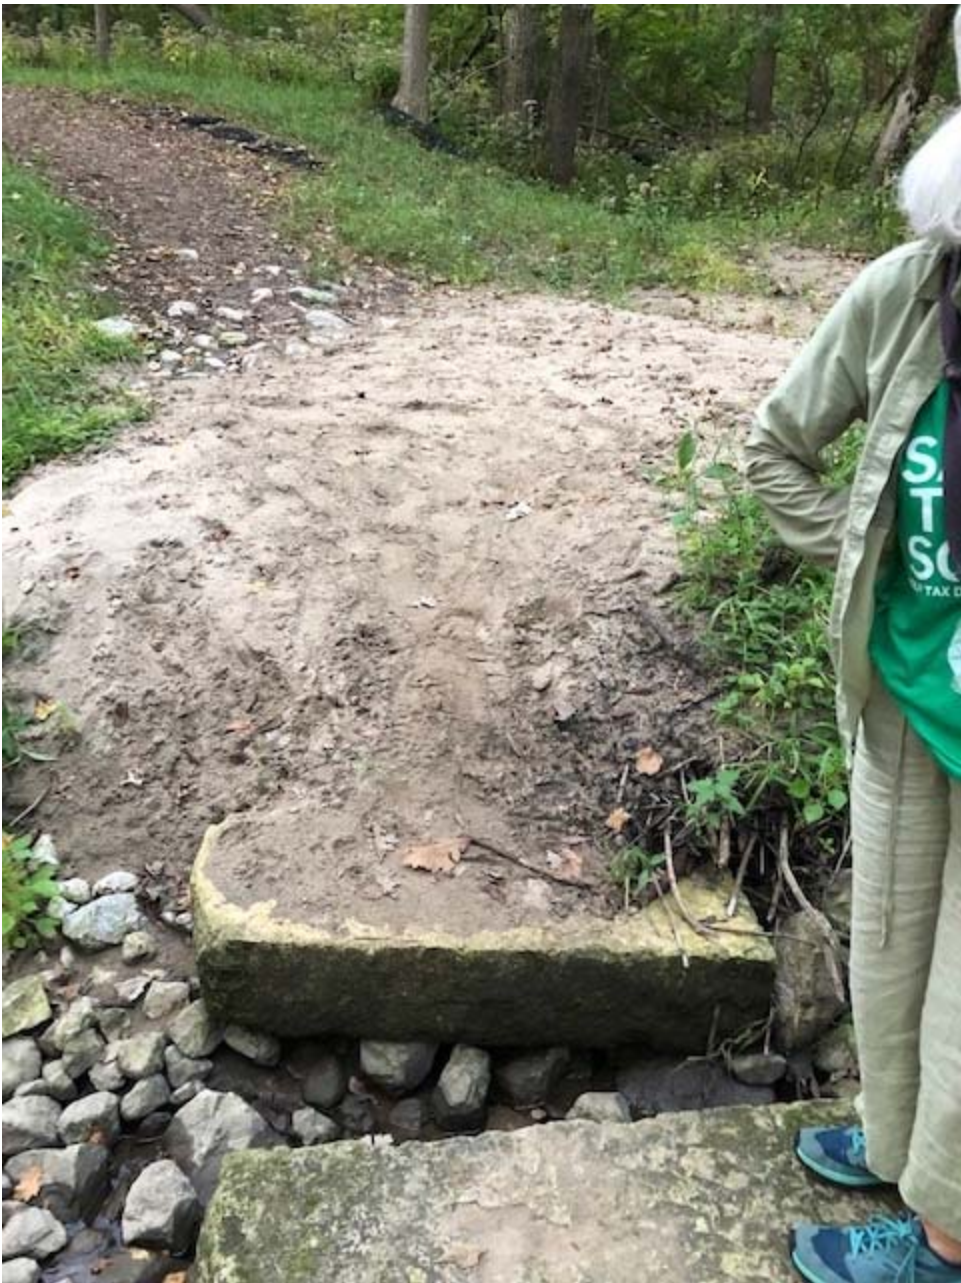
I have lived in the same house for 24 years and seen that woods and the features in them change over time; and that is part of their fascination for people. But, but they do so gradually (except when there's a derecho). These extreme and very sudden changes I am describing are man-made. The rock bridges have been a failure. The Stepping Stone bridge has a lovely motivation of connecting the parks, but it has caused damage to the creek and is not remotely sustainable. Again, these pictures show the silt deposits form very quickly now.
